LAKE NELSON DAM

NJ 00376

6 PHASE 1 INSPECTION REPORT  
NATIONAL DAM SAFETY PROGRAM.

Lake Nelson Dam (NJ 00376). Raritan River  
Basin, Ambrose Brook, Middlesex County,  
New Jersey. Phase 1 Inspection Report.

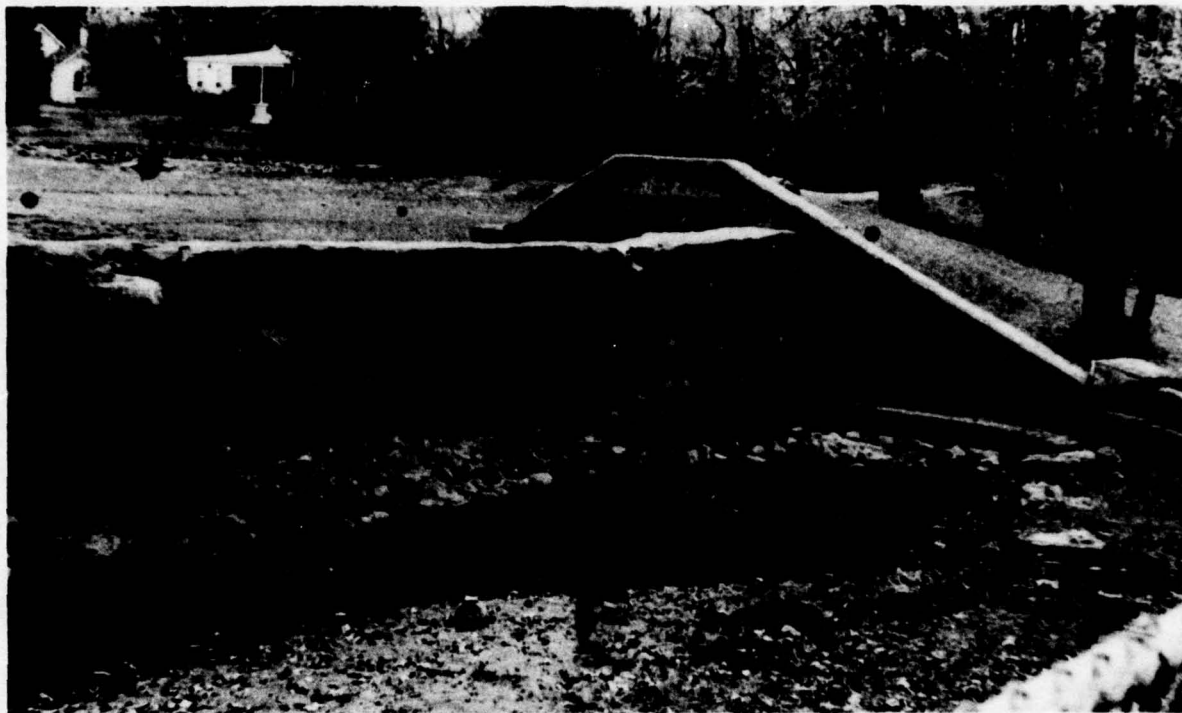
Photo A View of southern half of spillway (Oct. 28, 1973)  
(Photo courtesy of Haefeli Engineering, P.A.)

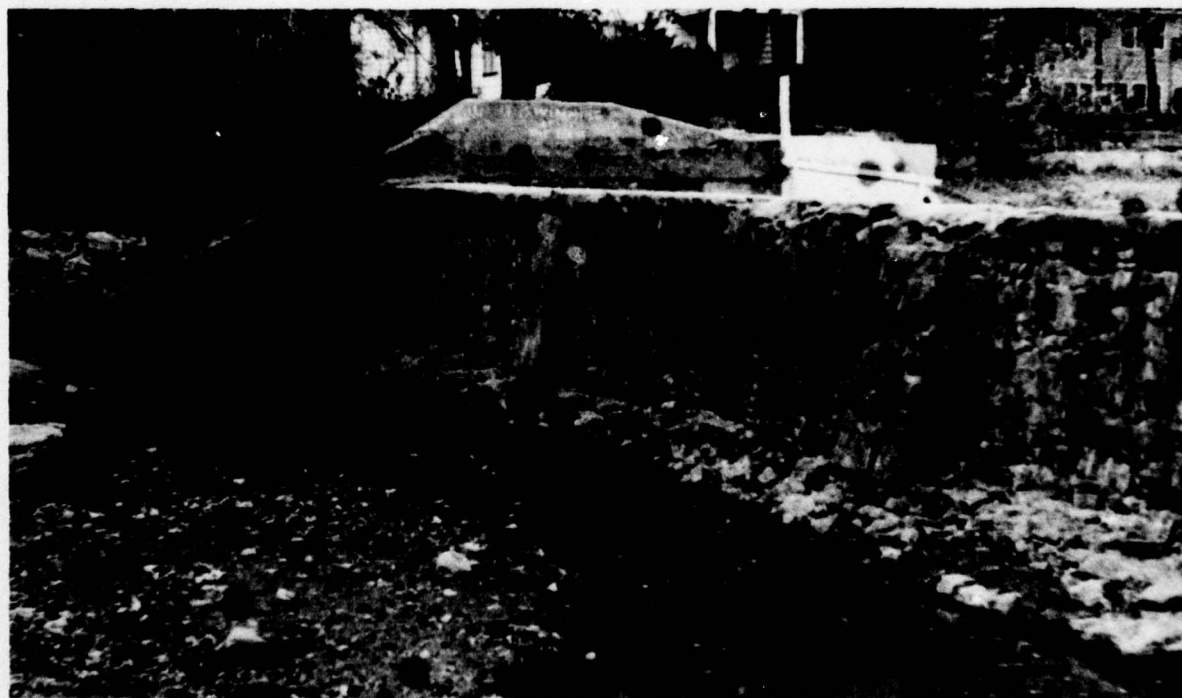
Photo B View of northern half of spillway (Oct. 28, 1973)  
(Photo courtesy of Haefeli Engineering, P.A.)

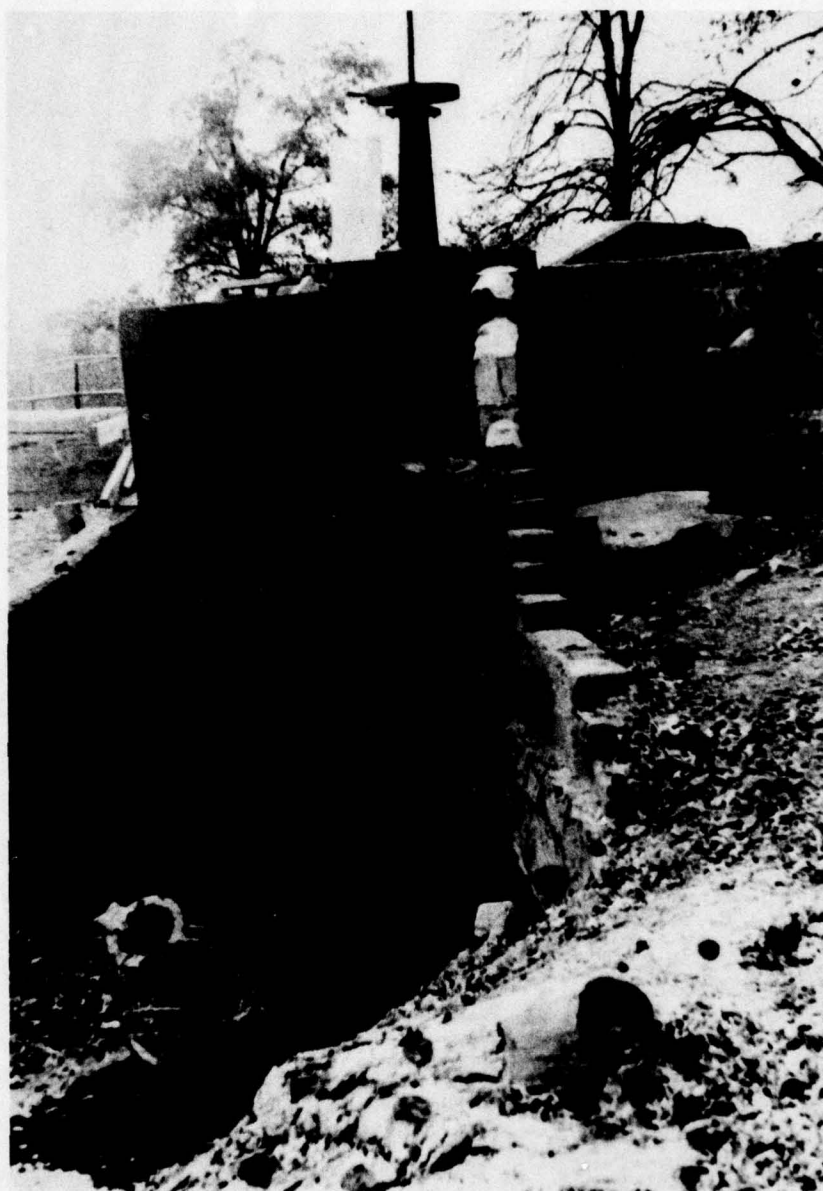
Photo C View of intake to outlet works looking  
downstream (Oct. 28, 1973)  
(Photo courtesy of Haefeli Engineering, P.A.)

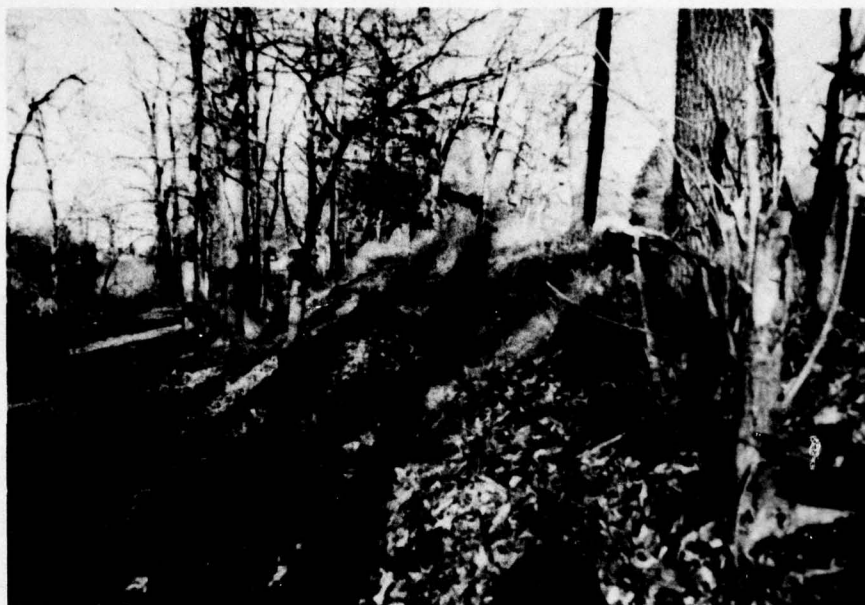
The embankment is covered with a relatively dense growth of mature trees (Photos 1, 2 and 3). A gully, approximately 20 feet long by 3 to 5 feet wide and 1 to 2 feet deep, was noted on the downstream face of the dam

Photo 1 View of downstream face of south embankment  
looking north

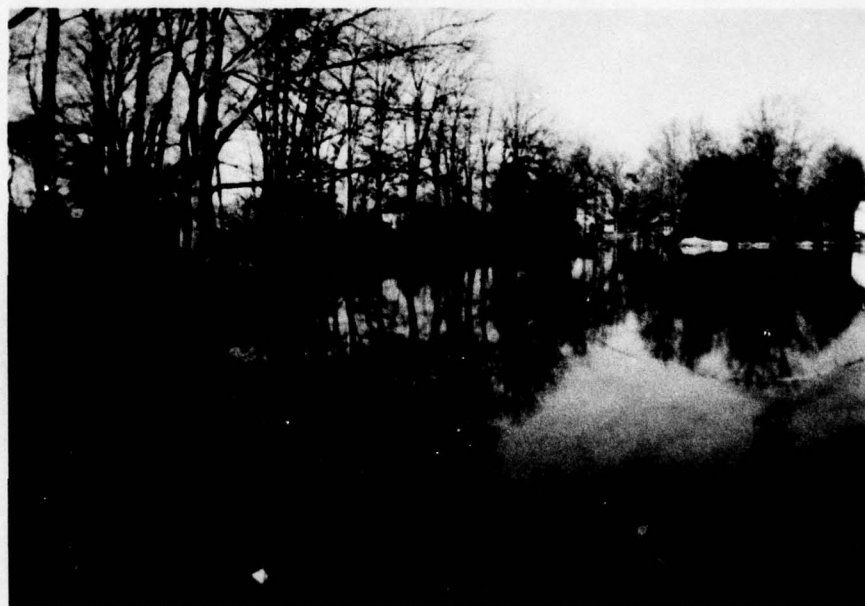
Photo 2 View of upstream face of dam from south  
abutment looking north

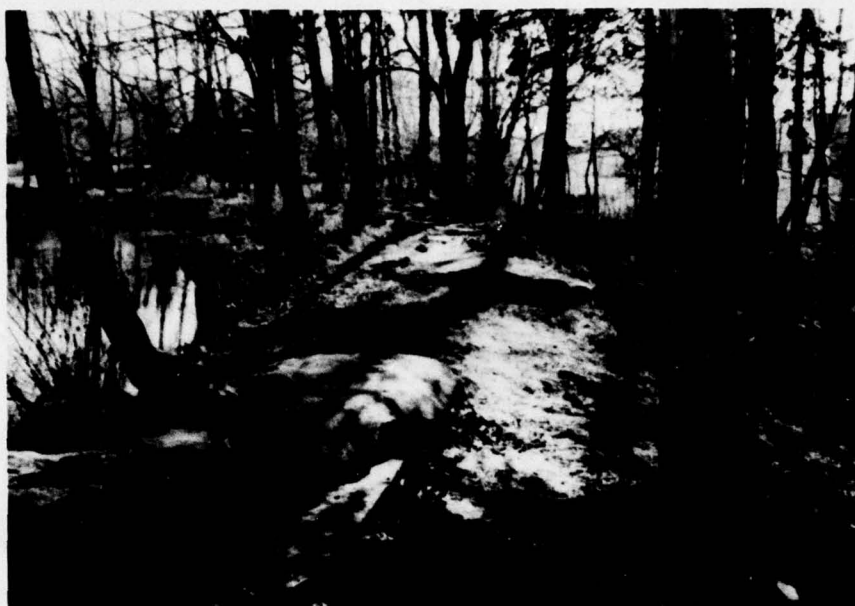
The remains of the emergency spillway consisting of a broken concrete slab approximately 20 feet long is located on the crest of the dam just south of the left spillway abutment (Photo 3). The top of this broken concrete slab is several inches higher than the average elevation of the embankment crest which is approximately 1.5 feet below the top of the concrete wing walls. The emergency spillway thus serves no function.

Photo 3 View of embankment crest looking south from  
spillway

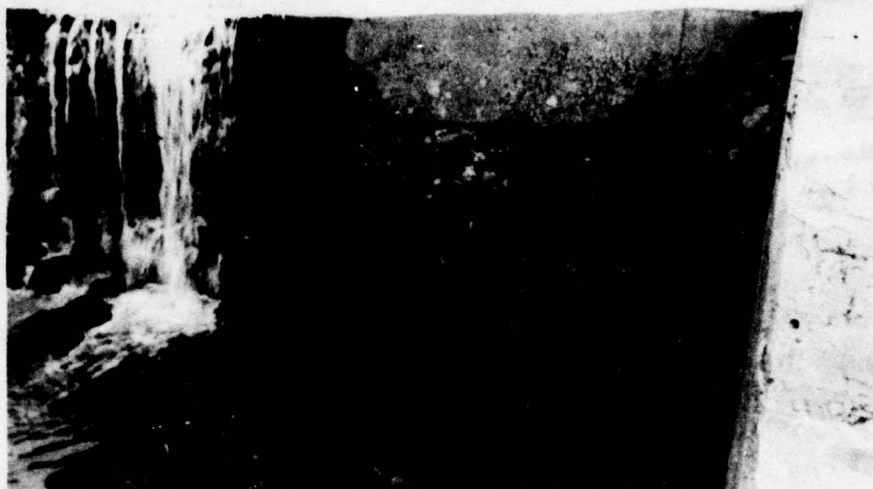
A breach in the spillway crest adjacent to the left (south) wing wall, about 10 feet long and 2 to 3 feet deep, has been filled with concrete; the surface of which is now approximately 3 inches higher than the rest of the spillway crest. Rubble masonry beneath this concrete cap has been partially undermined, and water was observed leaking through this section of the spillway (Photo 5).

The breach through the spillway crest adjacent to the left (south) abutment was repaired by placing a concrete cap in the eroded section. Water was observed seeping through the face of the spillway beneath the concrete cap and erosion causing partial undermining of the concrete cap has occurred. Therefore, the structural stability of this section of the spillway is questionable.

Photo 5 View of downstream face of spillway at left  
(south) abutment

3. The base of the two buttresses at the northern end of the downstream face of the spillway should be repaired.
4. The eroded portion of the spillway beneath the concrete cap should be repaired, and the concrete cap should be reconstructed.
5. Any erosion of the apron at the toe of the spillway should be repaired and undermined areas filled with concrete and stone.
6. The cracks and spalls in the concrete wing walls should be repaired.
7. The gully on the downstream face of the south embankment should be filled with suitable earth and compacted.
8. Riprap should be placed at sections at the upstream face of the embankment where the original riprap has been removed or dislodged.
9. A permanent extension should be added to the outlet pipe valve so that it can be operated from the top of the adjacent wing wall.

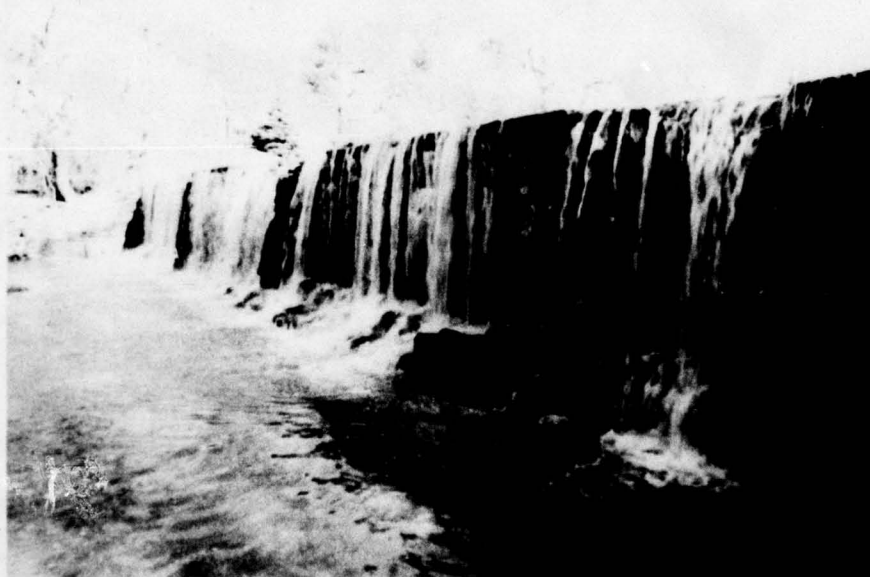
Photo 6 View of downstream face of spillway looking  
north

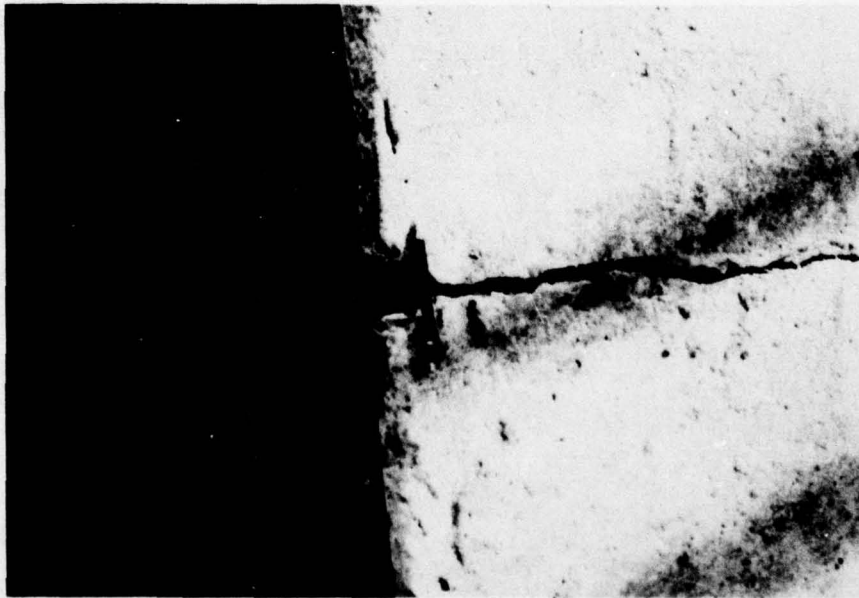
Cracking and spalling of the concrete wing walls at each abutment of the spillway was noted. A vertical crack  $1/8$  to  $1/4$  inch wide, plus spalling of the concrete on the surface adjacent to the crack were noted in the center of the left (south) wing wall (Photo 7). Cracking and displacement of about  $1/2$  inch were also noted in the left wing wall just downstream of the downstream edge of the spillway crest (Photo 8). Nearly vertical cracks were

Photo 7 Vertical view of crack  
at center of left (south)  
wing wall

- e. Any erosion of the apron at the toe of the spillway should be repaired and undermined areas filled with concrete and stone.
- f. The cracks and spalls in the concrete wing walls should be repaired.
